**BLOCK 1102, THIRD TO FOURTH STREET:** (Maps 2 & 21-23 ; Plates 19 & 20; Figures 34-36; Appendices 1 -5; and Plates 19 & 30)

## WILMINGTON BLVD. BLK. 1183

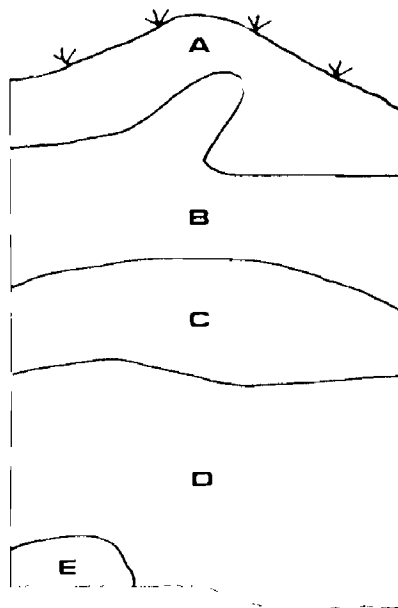
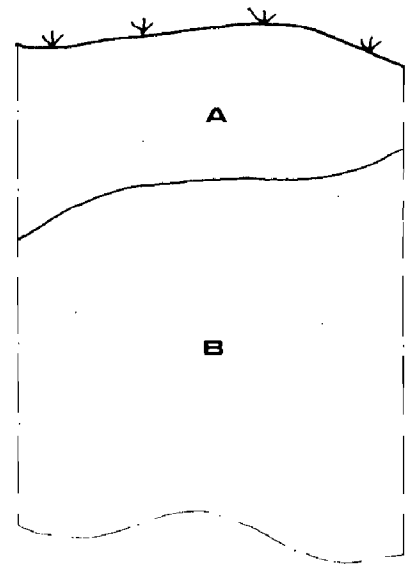
# FIGURE 31

placed at the rear of Lots 56 (Strata Cut 1) and 57 (Strata Cut 2) (Figure 31) identified natural soil horizons which remain in the center & rear yard portions of the block. No features were noted and no artifacts were present.

### PROFILE OF THE WEST WALL

**A** - 10YR 4/2 DARK GRAYISH BROWN LOAM MIXED WITH SOME CHARCOAL, CRUSHED SHELL, BRICK

**B** - 10YR 5/8 YELLOWISH BROWN CLAY LOAM

**C** - 10YR 4/6 DARK YELLOWISH BROWN SANDY LOAM

**D** - 10YR 4/6 DARK YELLOWISH BROWN SAND WITH SOME SILT

**E** - 5YR 5/8 YELLOWISH RED SANDY CLAY

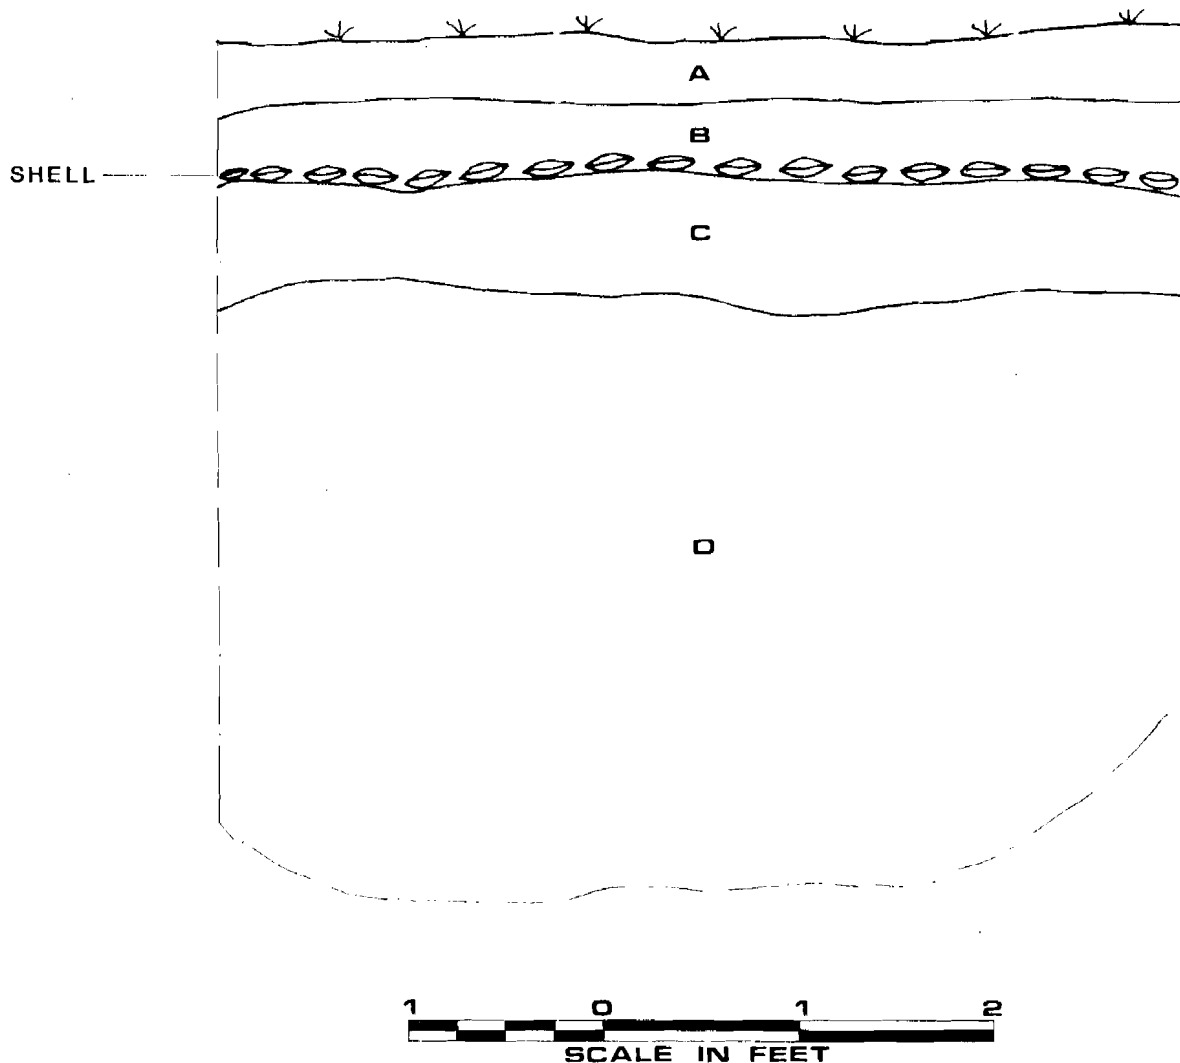
**FIGURE 32**  
**WILMINGTON BLVD. BLK. 1183**  
**TRENCH NO. 1**  
**PROFILE OF THE NORTH WALL**

Backhoe Trench #1 in the rear of lot 40 encountered cultural horizons and natural soil stratigraphy (Figure 32). This profile is consistent with Strata Cuts 1 & 2. Backhoe Trench #2 in the rear of Lot 39, however, was placed in an area that had been subject to severe demolition and revealed 3.0' of sterile select fill (Figure 33). No artifacts were present in either trench.

**A** - 10YR 3/2 DARK GRAYISH BROWN TOPSOIL, SILT LOAM WITH ARTIFACTS

**B** - 10YR 5/6 YELLOWISH BROWN LOAM, BRICK FRAGMENTS, GLASS, CHARCOAL

**C** - 10YR 4/4 DARK YELLOWISH BROWN LOAM, BRICK FLECKS, POSSIBLY BROUGHT DOWN BY ROOT ACTION OF CULTURAL MATERIALS, SHELL

**D** - 10YR 5/8 YELLOWISH BROWN STERILE CLAY

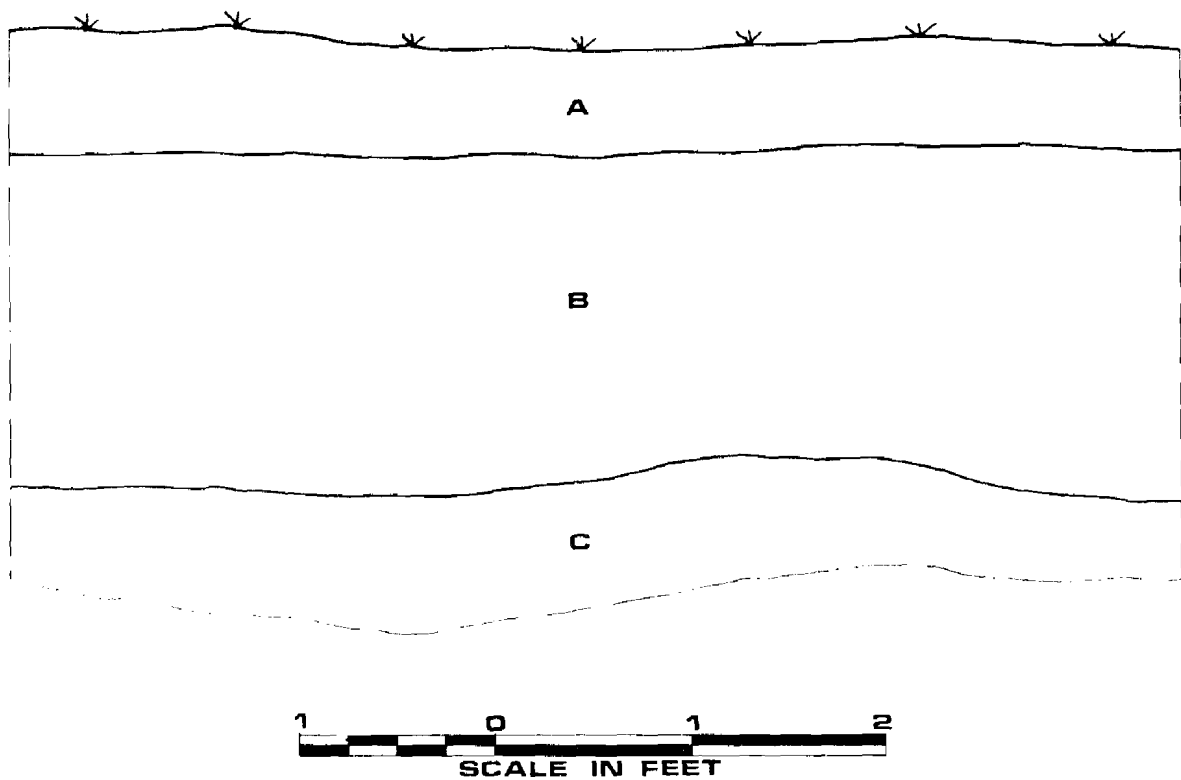
**FIGURE 33**  
**WILMINGTON BLVD. BLK. 1183**  
**TRENCH NO. 2**  
**PROFILE OF THE EAST WALL**

**A** - 7.5YR 5/8 STRONG BROWN SELECT FILL

**B** - 10YR 4/6 DARK YELLOWISH BROWN SILTY LOAM WITH MOTTLING OF 10YR 5/4  
YELLOWISH BROWN, STERILE

**C** - 7.5YR 5/8 STRONG BROWN CLAY STREAKED WITH 10YR 5/2 GRAYISH BROWN CLAY

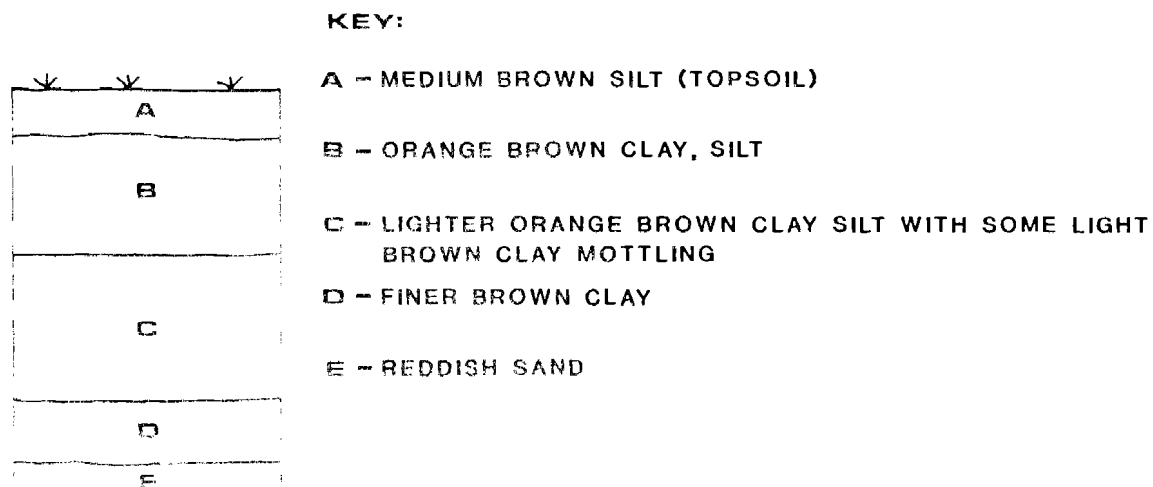
# FIGURE 34

Two strata cuts were placed against an existing three foot bank cut on Lot 34 (Map 20). Figure 34 shows the stratigraphic profiles encountered, which were interpreted as natural soil horizons. No occupation levels or features were identified and no artifacts were present. This location corresponds with the rear yard of the structure on the east of the Wagon Manufactory in 1884 (Map 18).

### PROFILE OF THE WEST WALL

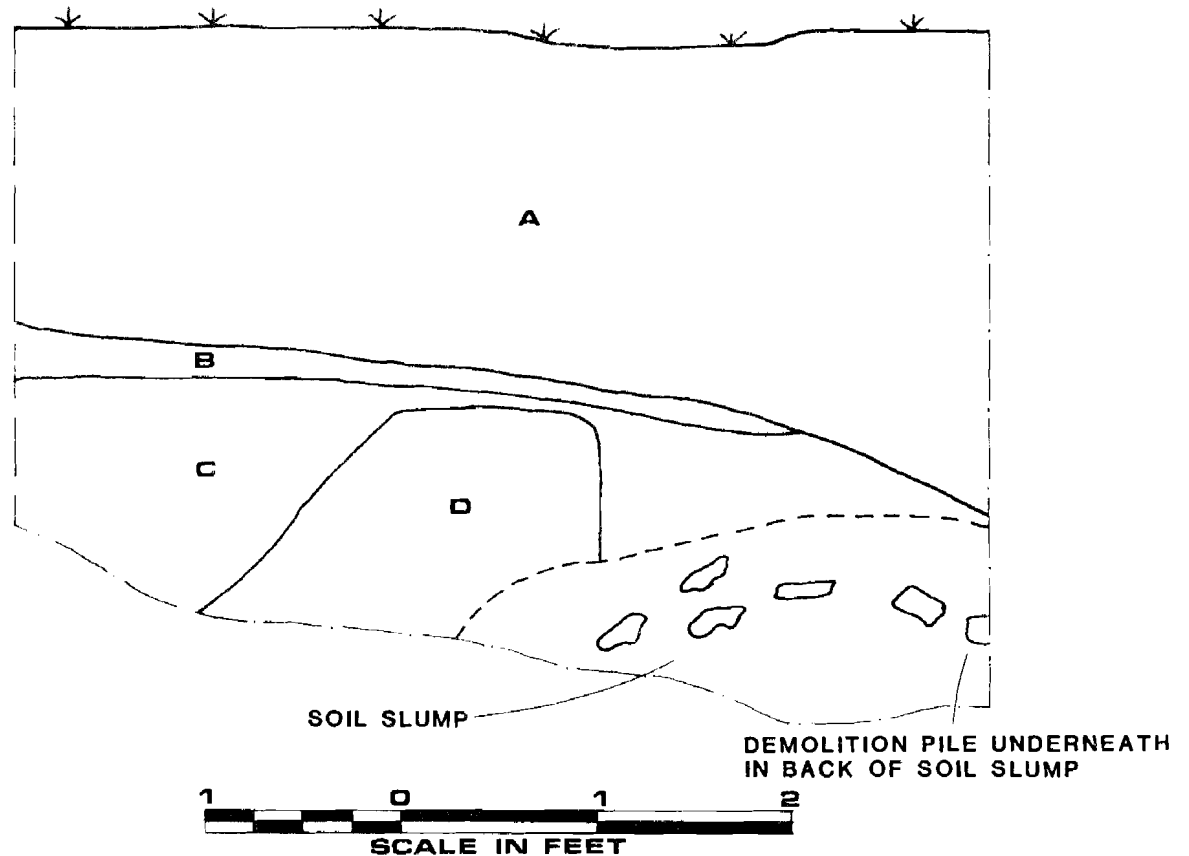
**FIGURE 35**  
**WILMINGTON BLVD. BLK. 1102**  
**TRENCH NO. 1**  
**PROFILE OF THE EAST WALL**

The stratigraphic profile of Trench #1, which bisected the property line between the two lots and should have encountered building foundations (Map 20), uncovered approximately 4.0' of select fill (Figure 35). Structural demolition on these two lots removed all cultural materials. No artifacts were present.

**A - 10YR 5/8 YELLOWISH BROWN SELECT FILL**

**B - 7.5YR 5/8 STRONG BROWN BAND OF SAND**

**C - 7.5YR 5/8 STRONG BROWN SAND STREAKED WITH MOTTLING OF 5YR 4/6 RED & 10YR 6/8 BROWN YELLOW**

**D - 2.5YR 4/6 RED CLAY**

**NOTE: NO CULTURAL MATERIAL EVIDENT, APPEARS TO BE FILL ALL THE WAY TO THE BOTTOM WITH A POCKET OF DEMOLITION MATERIAL AT BOTTOM OF THE SOUTH END OF THE PIT**

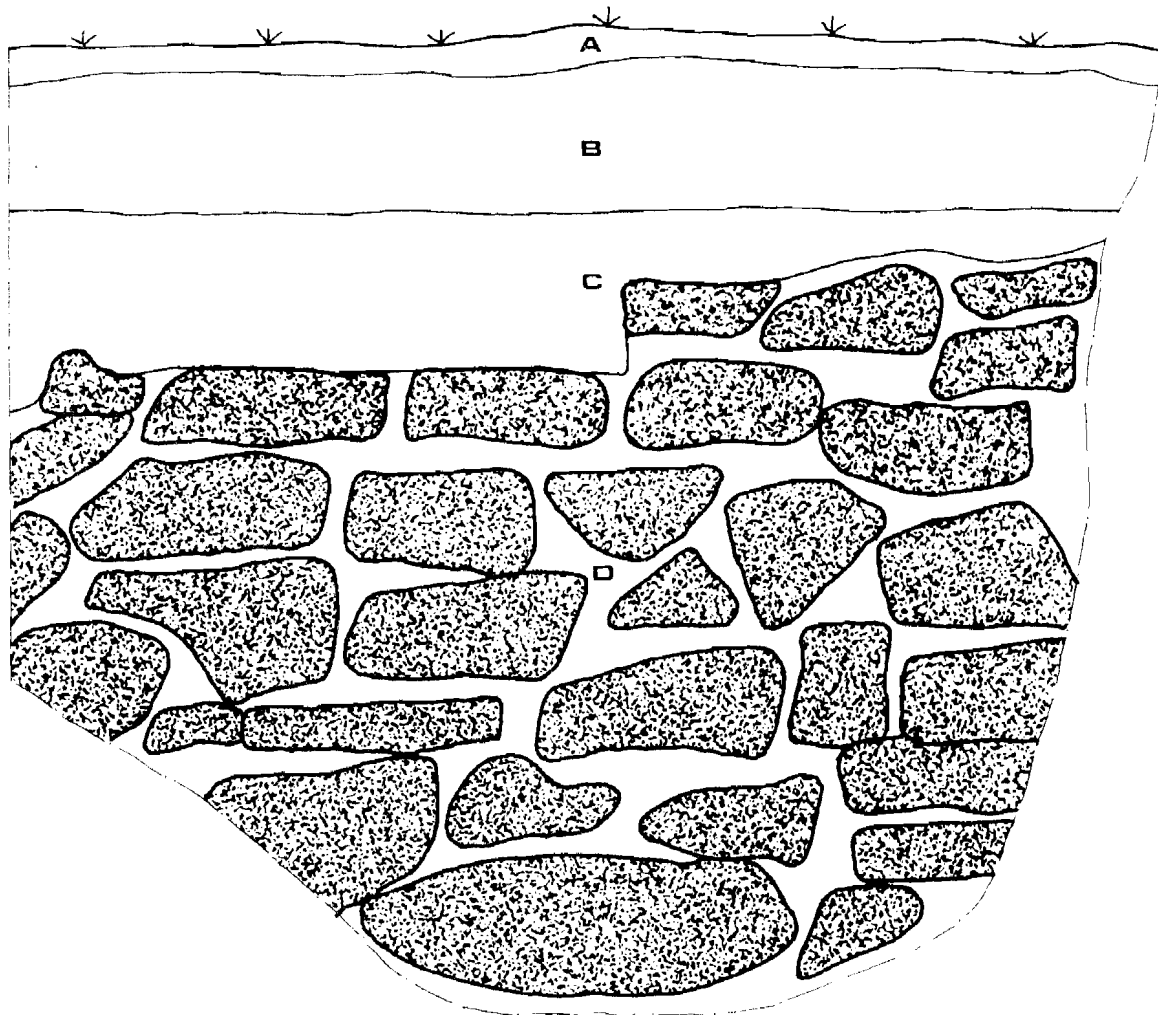
**FIGURE 36**  
**WILMINGTON BLVD. BLK. 1102**  
**TRENCH NO. 2**  
**PROFILE OF THE SOUTH WALL**

Trench #2 was placed in order to locate the presence of features and deposits relating to the 18th-century occupation and to 19th-century schoolyard activities. Figure 36 illustrates that the school foundation was encountered (Map 18). The trench was excavated in what was apparently the cellar, only brick demolition rubble was encountered. No artifacts were present. Since the school building had a cellar, all evidence of the 18th-century occupation near Walnut Street cannot be expected to remain. Eighteenth century yard features may be intact in the

**A - ASPHALT PAVEMENT**

**B - TRAP ROCK**

**C - 10YR 5/6 YELLOWISH BROWN SAND FILL WITH SOME BRICKS, RUBBLE, MORTAR**

**D - 7.5YR 6/8 REDDISH YELLOW, STONE FOUNDATION, MORTAR**
